# Chapter 1: Introduction and Description of the Upper Rio Grande Flood Planning Region

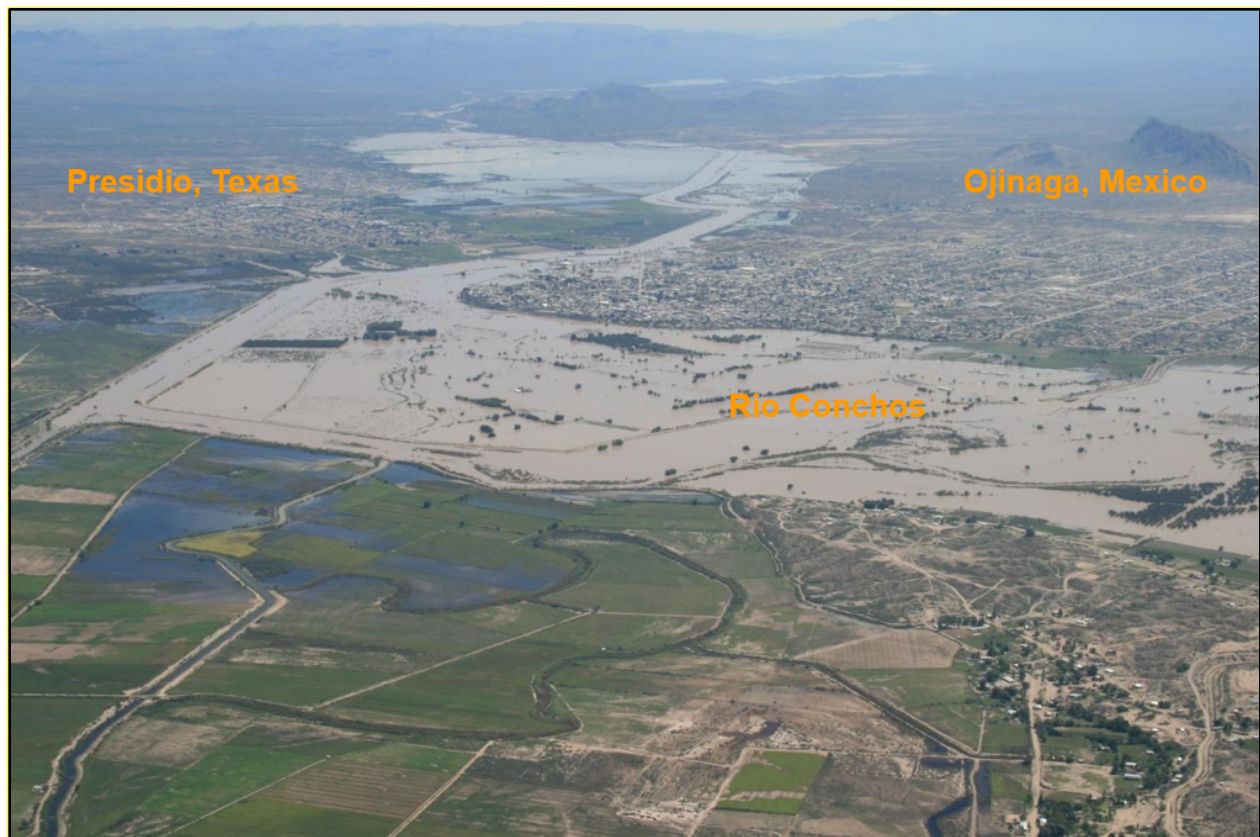
**Figure 1.7 Flooding along the Rio Grande and Rio Conchos in Presidio, Texas and Ojinaga, Mexico on September 19, 2008**

A significant flooding event also affected Presidio, Texas, and Ojinaga, Mexico in September 2008, causing damaging flooding along the Rio Grande and Rio Conchos as shown in **Figure 1.7**. This storm, centered over the Rio Conchos watershed in Mexico, sent a massive flood down the Rio Conchos into the Rio Grande. Flooding occurred along the Rio Grande from the confluence with the Rio Conchos to Amistad Reservoir. This flood breached and/or overtopped both US and Mexican levees at locations along the Rio Conchos and the Rio Grande. Flooding in Presidio was primarily limited to the low-lying farmland adjacent to the levees.

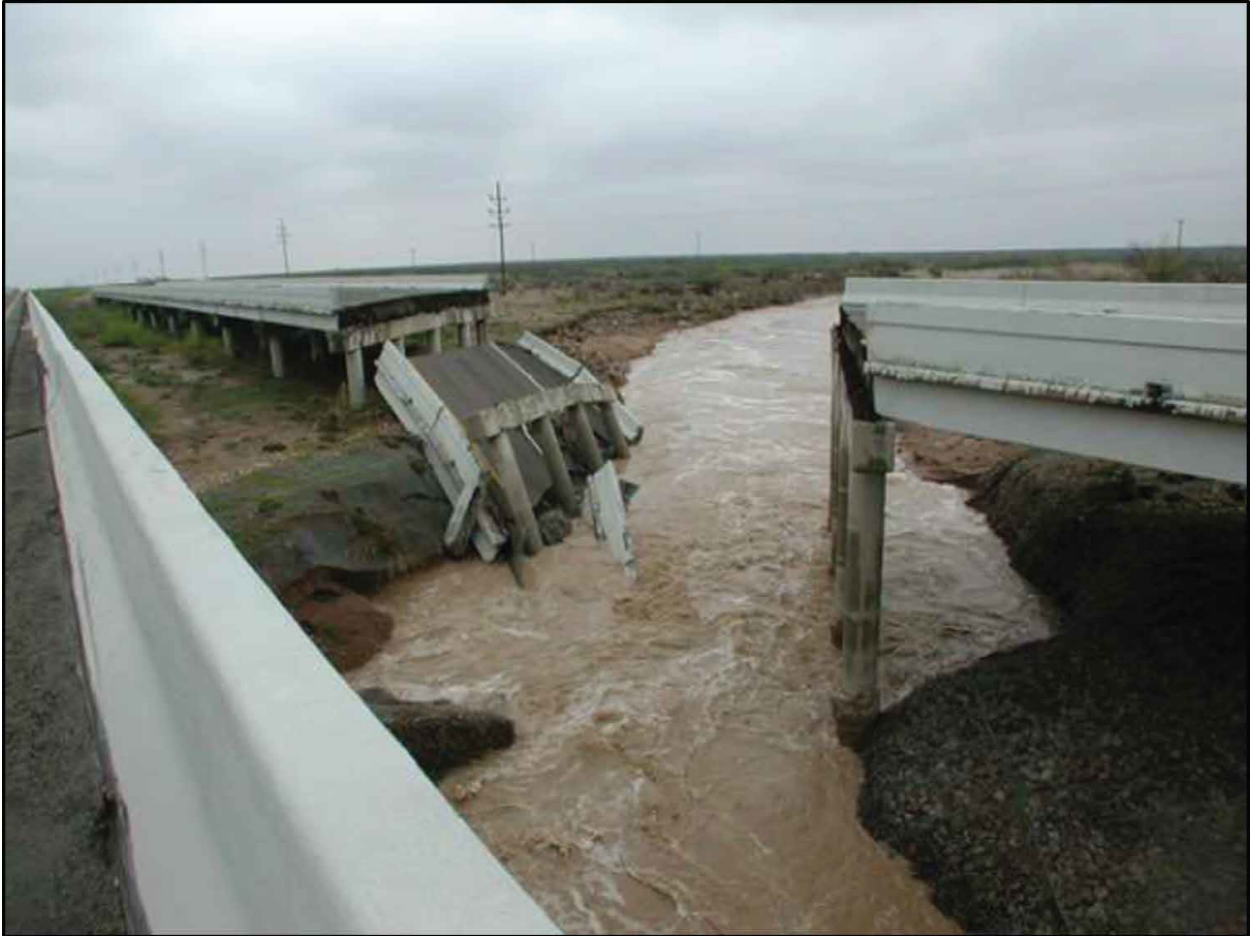
**Figure 1.8 Toyah and Pecos, Texas, 2004 Flood**

Historic Flooding occurred in April 2004 in Pecos and Reeves County, resulting in significant flooding downstream of Comanche Creek Dam in Fort Stockton and a collapsed I-20 bridge over Salt Draw between Toyah and Pecos (see **Figure 1.8**). In addition, a levee protecting Toyah was breached during the flood event.

April 2004 flood caused this I-20 bridge over Salt Draw to collapse, located between Toyah and Pecos. Source: NOAA and NWS; [https://www.weather.gov/maf/2004\\_04\\_02\\_SevereWeather](https://www.weather.gov/maf/2004_04_02_SevereWeather)

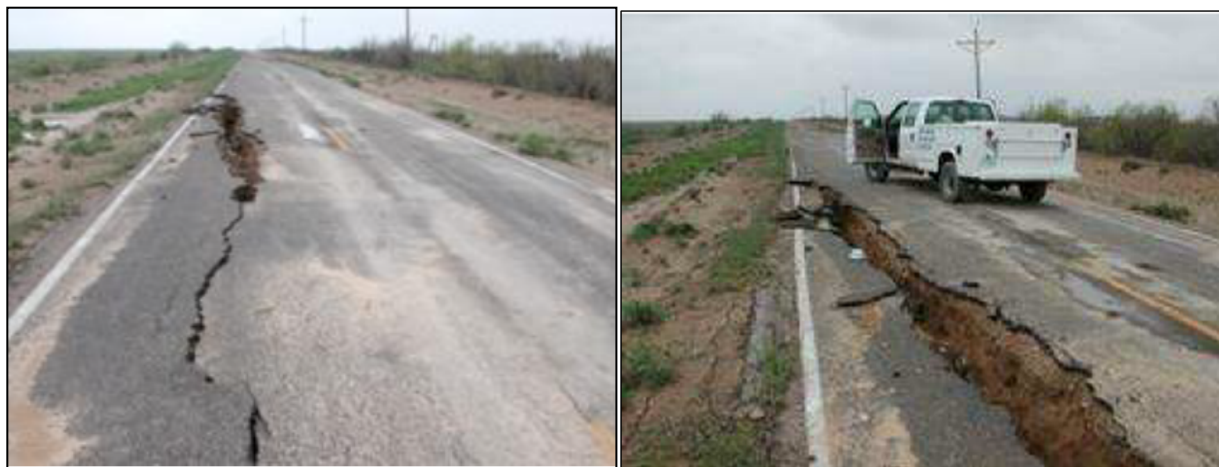
**Figure 1.9 Sinkholes in Pecos, Texas, April 2004 Flood**

Sinkholes have also formed in Region 14 during or immediately after significant flood events. This occurred during the April 2004 flood event along a County Road located southwest of the City of Pecos, as shown in **Figure 1.9**.

Sinkholes formed along this County Road southwest of Pecos, Texas during the April 2004 storm event.  
Source: NOAA and NWS; [https://www.weather.gov/maf/2004\\_04\\_02\\_SevereWeather](https://www.weather.gov/maf/2004_04_02_SevereWeather)
